# Manhole Inspection Summary

Manhole # S27Q\_\_004MH

**Location** Address: **1315 Bayard ST**

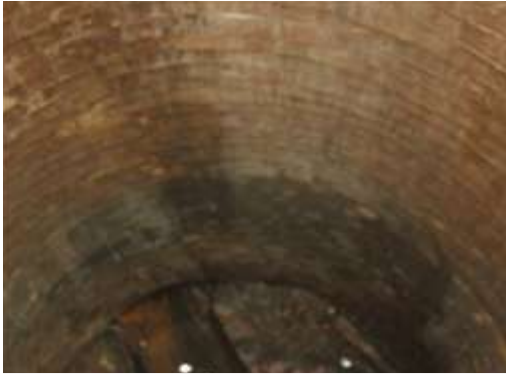
Defect 5

Infiltration: ☐ None ☐ Joint ☐ Cracks ☒ **Mortar** ☐ Roots ☒ **Wall**

signs of barrel infiltration

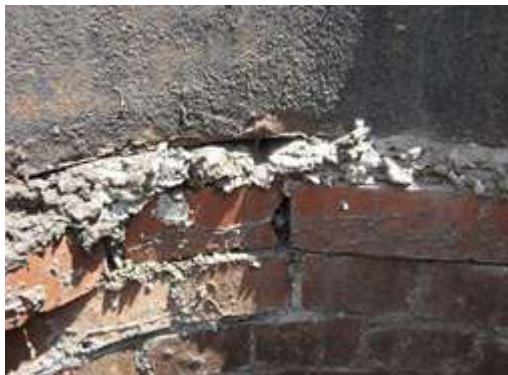
Defect 3

Condition: ☐ Sound ☒ **Cracked** ☐ Root Intrusion ☐ Loose Brick ☒ **Deteriorated**

cracked deteriorated chimney, missing mortar

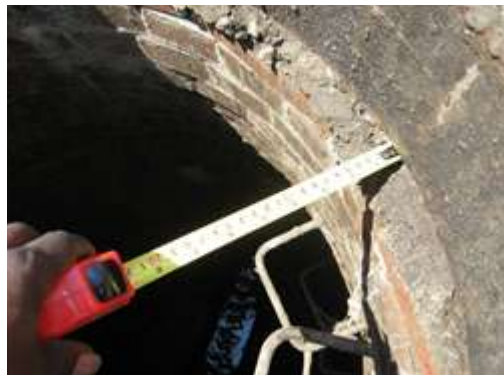
Defect 2

**Frame** Offset: **1.** (in.) Condition: ☒ Sound ☐ Cracked ☐ Leaks  
**75**

frame offset

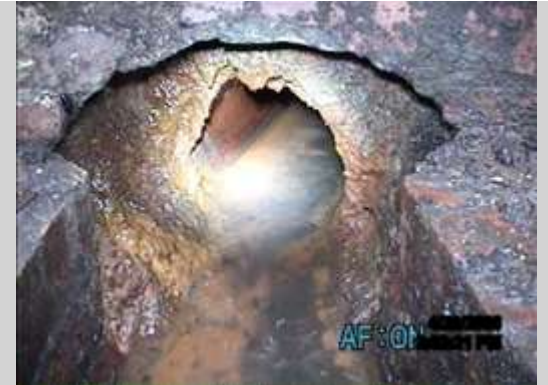
12 O'Clock Outflow

area around pipe seems deteiorated

Pipe Height: **14.4** (in.) Rod and Bar (Angled)  
Pipe Material: **Clay** ☐ Pipe Lined  
Invert Depth: **11.36** (ft.) Flow Characteristics: **Fast**  
Deposits: ☒ None ☐ Mud ☐ Sludge ☐ Debris ☐ Grease  
Silt Depth: **0** (in.) Deposits Extent:  
Infiltration: **Evidence** Pipe Seal Cond: **Broken**

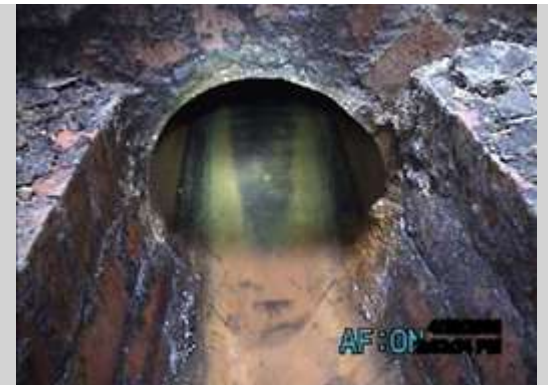
5 O'Clock Inflow

Pipe Height: **12** (in.) Rod and Bar (Angled)  
Pipe Material: **Clay** ☐ Pipe Lined  
Invert Depth: **11.37** (ft.) Flow Characteristics: **Slow**  
Deposits: ☒ None ☐ Mud ☐ Sludge ☐ Debris ☐ Grease  
Silt Depth: **0** (in.) Deposits Extent:  
Infiltration: **Evidence** Pipe Seal Cond: **Sound**
